# INSPECTION REPORT

For the Property at:  
**27 MAPLE CRESCENT**  
CHICAGO, IL

Prepared for: JOHN SIMPSON  
Inspection Date: Thursday, January 4, 2007  
Prepared by: Alan Carson

Report No. 1366, v.6

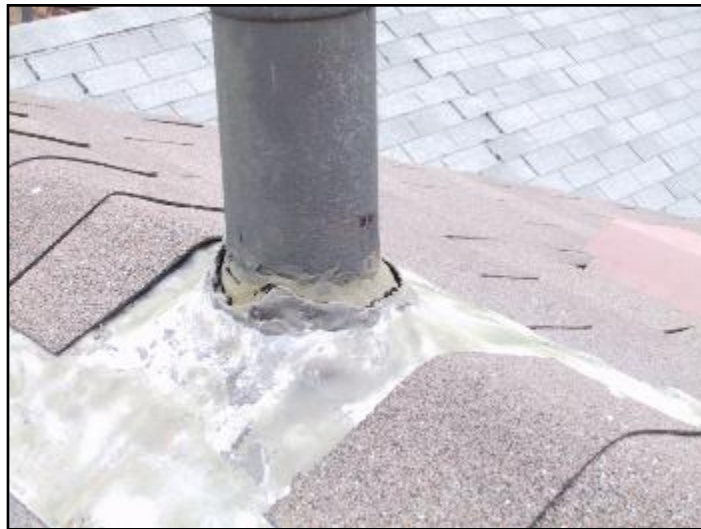
**Condition:** • [Leak](#)

**Implication(s):** Chance of water damage to contents, finishes and/or structure

2. Stack flashing should be sealed.

**Task:** Repair

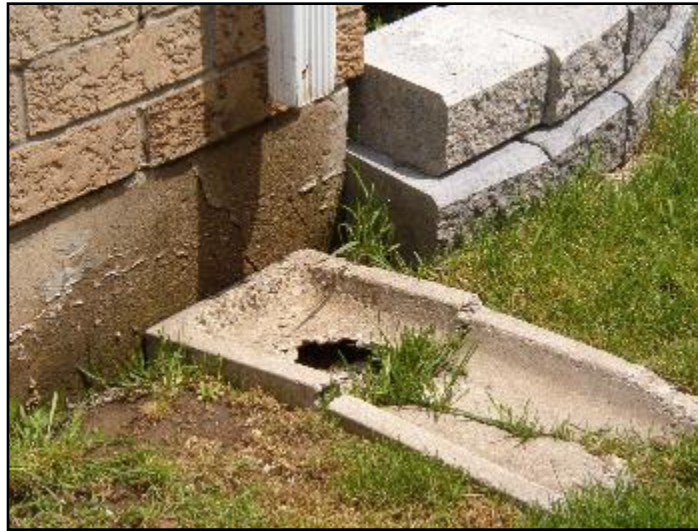
**Condition:** • [Downspouts end too close to building](#)

**Implication(s):** Chance of water damage to contents, finishes and/or structure

**3.** *Downspout should be extended away from home*

**Note:** The downspout should be extended to discharge at least 6 feet from the home. The broken splash block can be discarded.

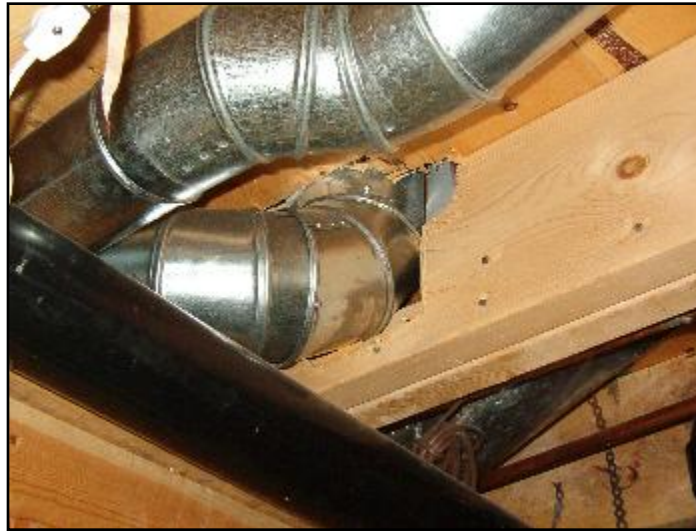
**Condition:** • [Notches or holes](#)

**Implication(s):** Weakened structure

4. Double joist cut for ductwork

**Task:** Repair

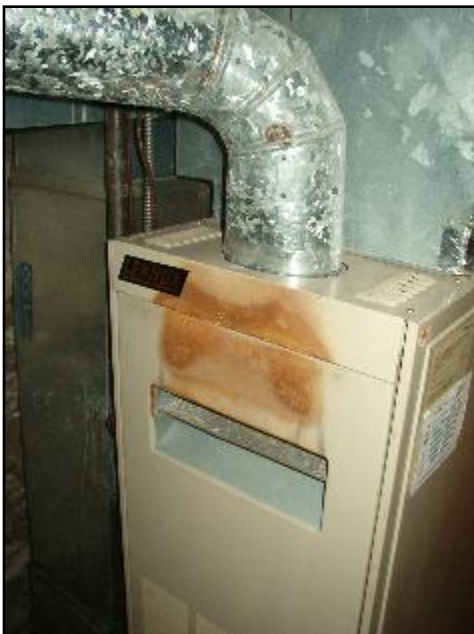
**Condition:** • [Draft hood spillage or backdraft](#)

**Implication(s):** Equipment not operating properly | Hazardous combustion products entering home

9. Evidence of furnace backdrafting

**Task:** Correct

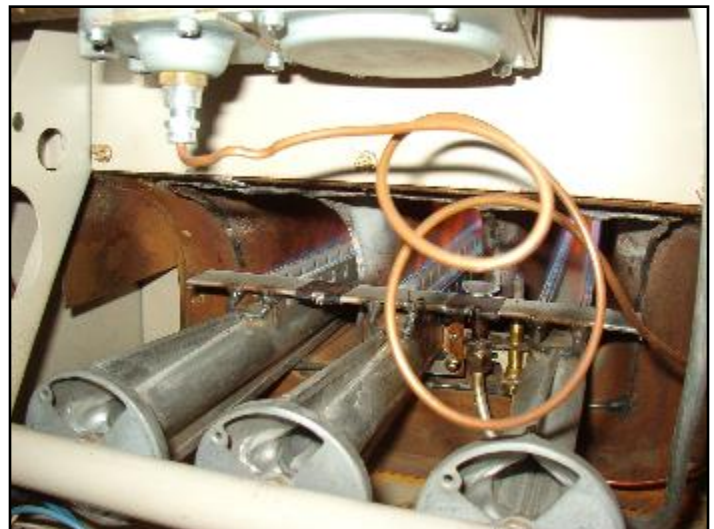
10. Rust at bottom of heat exchanger

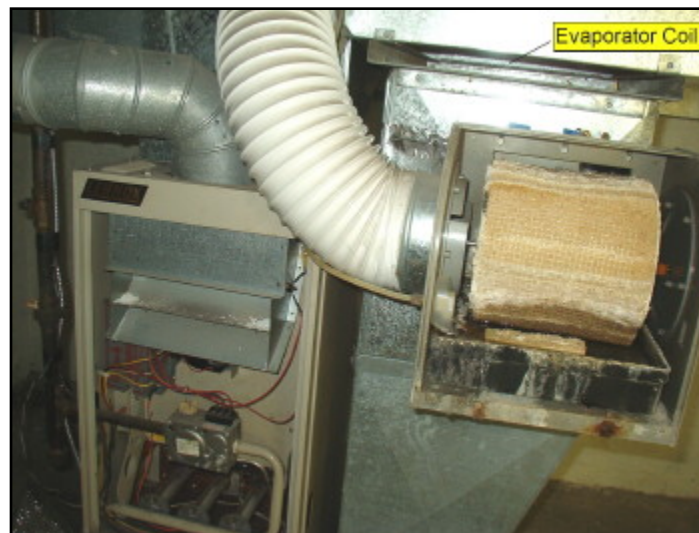
**Condition:** • [Leak](#)

**Implication(s):** Chance of water damage to contents, finishes and/or structure | Damage to equipment

11. Leaking and inoperative humidifier

**Task:** Repair or replace

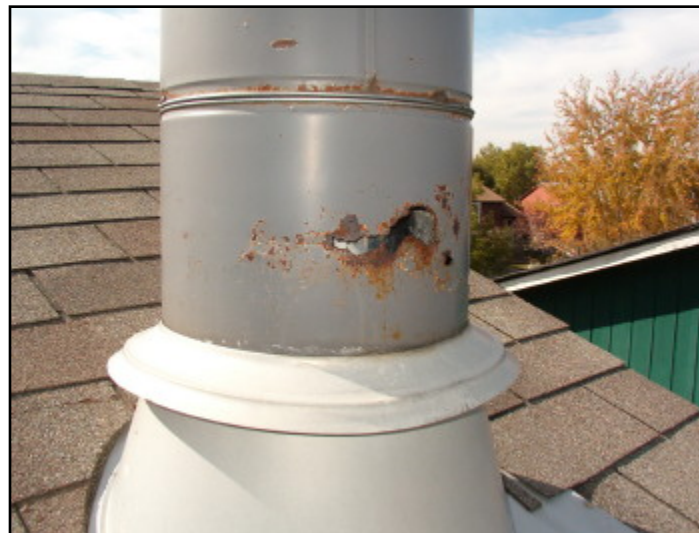
Condition: • [Chimney walls rusting or pitting](#)

Implication(s): Chance of movement | Hazardous combustion products entering home

13. Rusted chimney wall from fireplace

Task: Replace

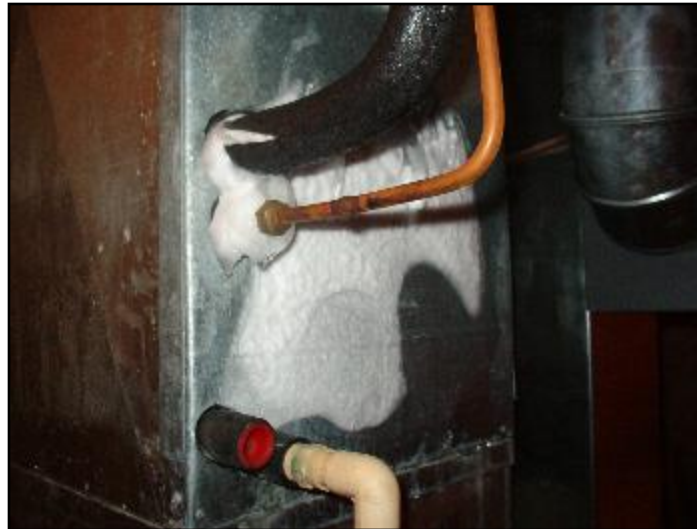
**Condition:** • [Frost](#)

**Implication(s):** Increased cooling costs | Reduced comfort

14. Frost visible on ductwork at AC coil

**Task:** Repair

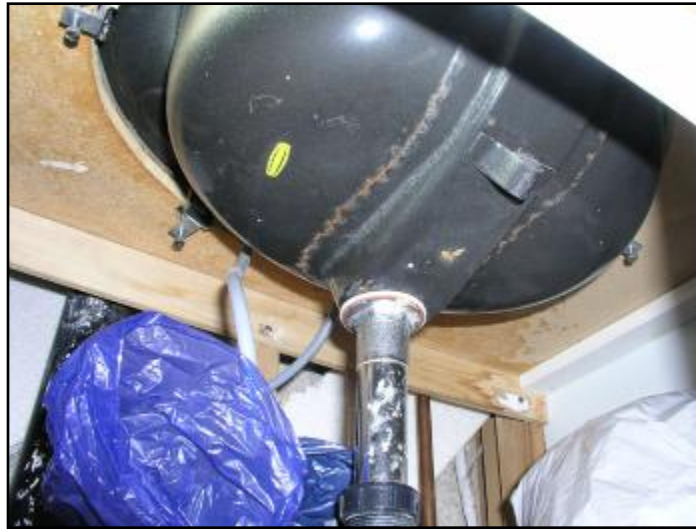
**Condition:** • [Rust](#)

**Implication(s):** Cosmetic defects | Chance of water damage to contents, finishes and/or structure

19. *Steel basin rusting at weld*

**Task:** Replace

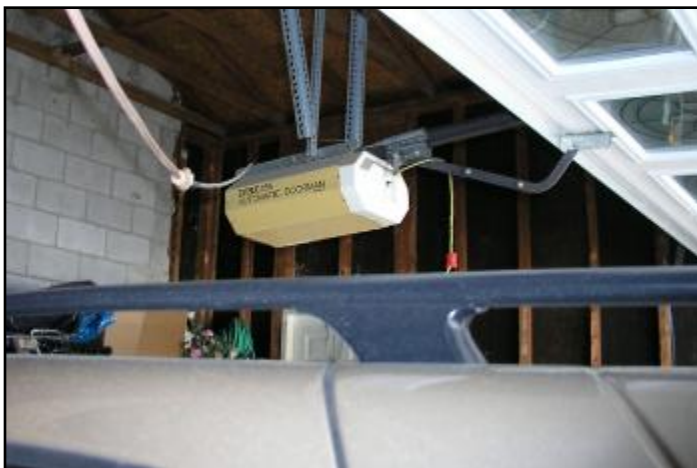
**Condition:** • [Extension cord for opener](#)

20. Extension cord for west garage door opener

**Task:** Replace with permanent wiring
