# INSPECTION REPORT

For the Property at:  
**27 MAPLE CRESCENT**  
CHICAGO, IL

Prepared for: JOHN SIMPSON  
Inspection Date: Thursday, January 4, 2007  
Prepared by: Alan Carson

Report No. 1366, v.6

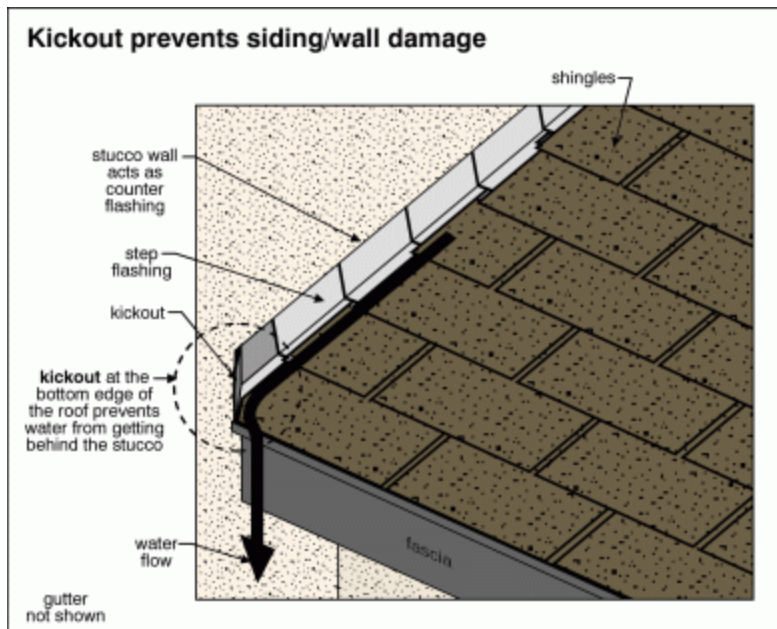
**Condition:** • [No kickout flashing](#)

**Implication(s):** Chance of water damage to contents, finishes and/or structure

**Task:** Improve

**Time:** Less than 1 year

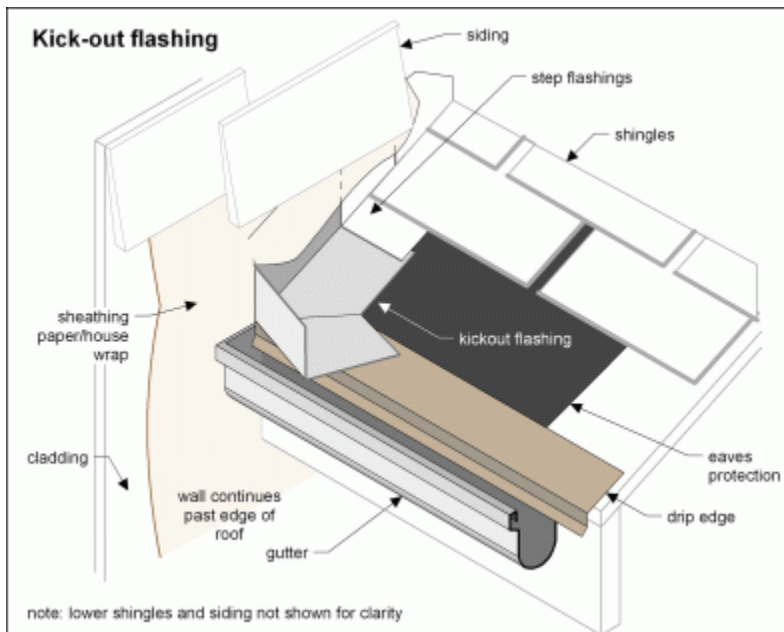
**Condition:** • [Leak](#)

**Implication(s):** Chance of water damage to contents, finishes and/or structure

**Task:** Repair

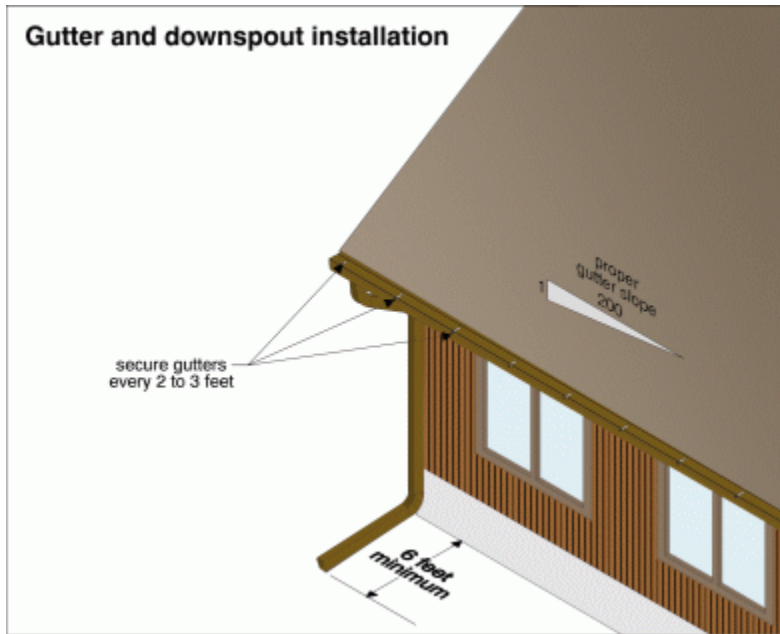
**Condition:** • [Downspouts end too close to building](#)

**Implication(s):** Chance of water damage to contents, finishes and/or structure

**Time:** Immediate

**Note:** The downspout should be extended to discharge at least 6 feet from the home. The broken splash block can be discarded.

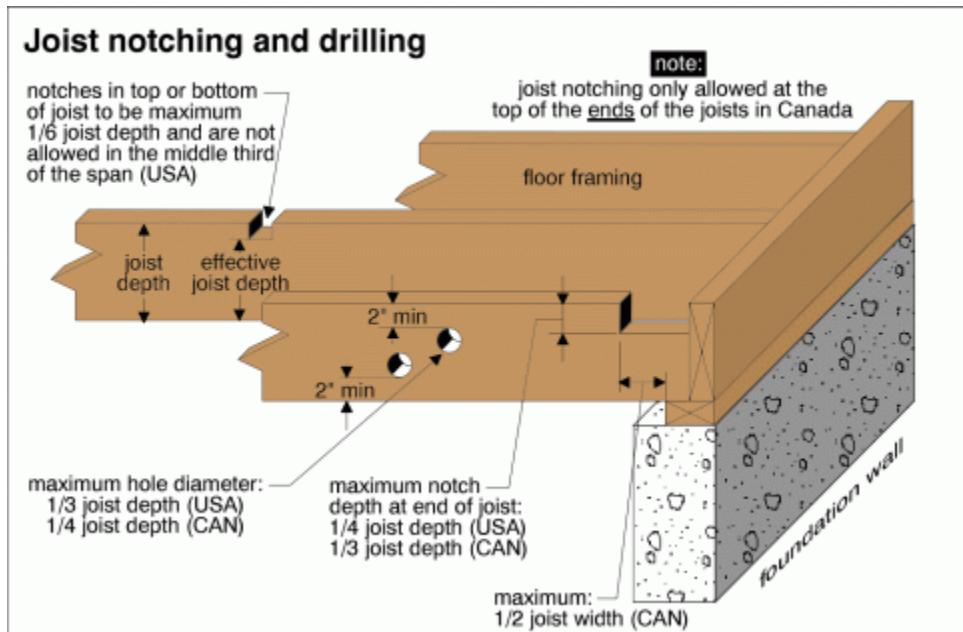
**Condition:** • [Notches or holes](#)

4. Double joist cut for ductwork

**Task:** Repair

**Time:** Immediate

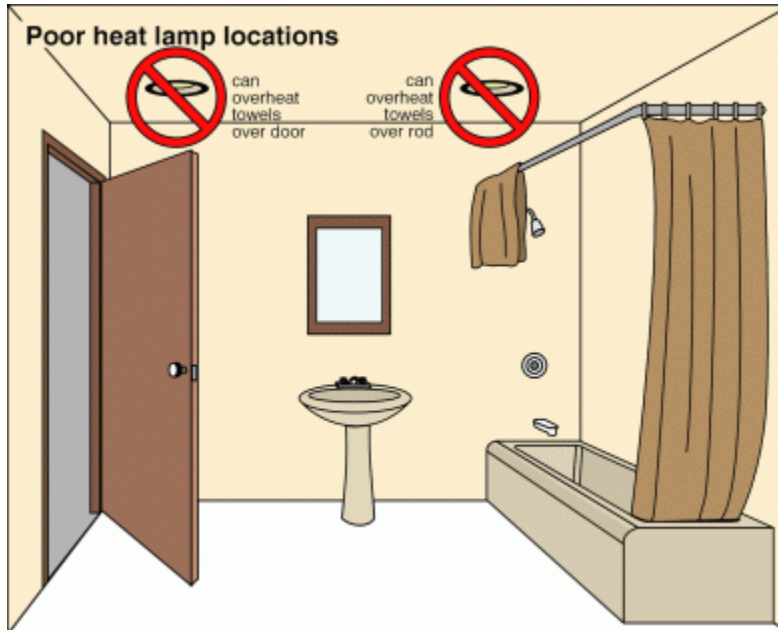
**Condition:** • [Heat lamps over doors](#)

**Implication(s):** Fire hazard

8. Heat lamp over door - fire hazard!

**Task:** Correct

**Time:** Immediate

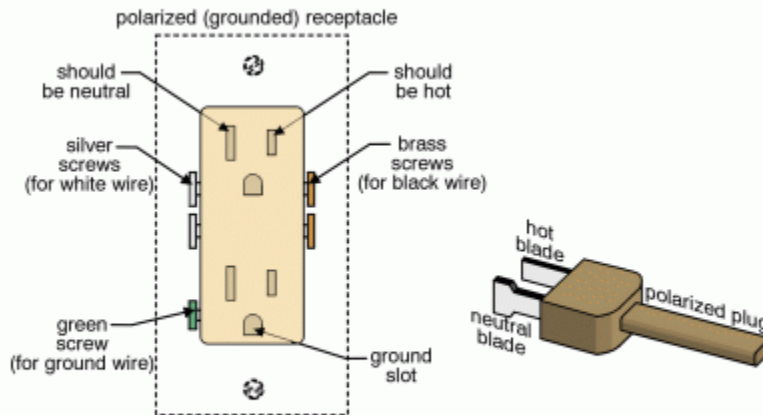
## Reversed polarity

**Condition:** • [Reversed polarity](#)

when the polarity is reversed, the wide receptacle slot is (incorrectly) hot and the narrow slot is neutral - this is not uncommon when people forget that the black wire should be attached to the receptacle's brass screws

**Time:** Less than 1 year

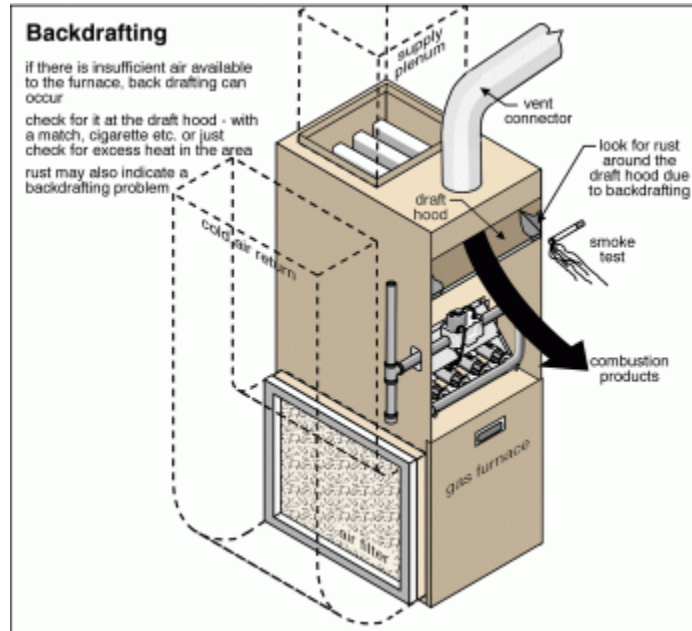
**Condition:** • [Draft hood spillage or backdraft](#)

**Task:** Correct

**Time:** Immediate

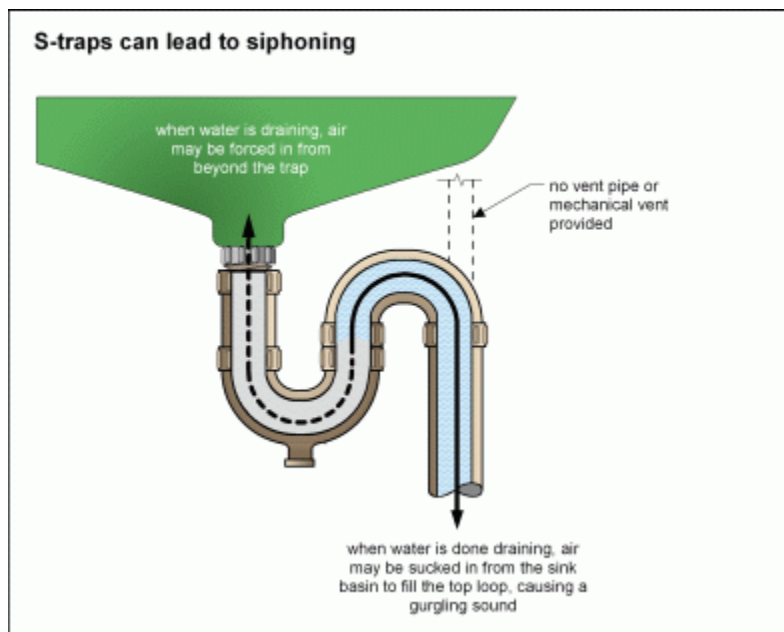
**Note:** This configuration is prone to clogging problems

**Time:** Less than 1 year

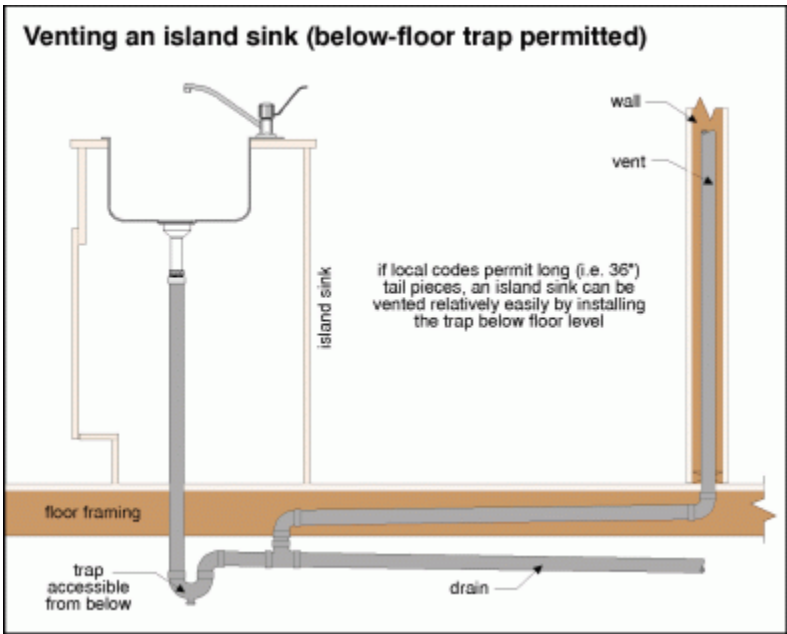
**Location:** Kitchen

**Task:** Provide proper venting

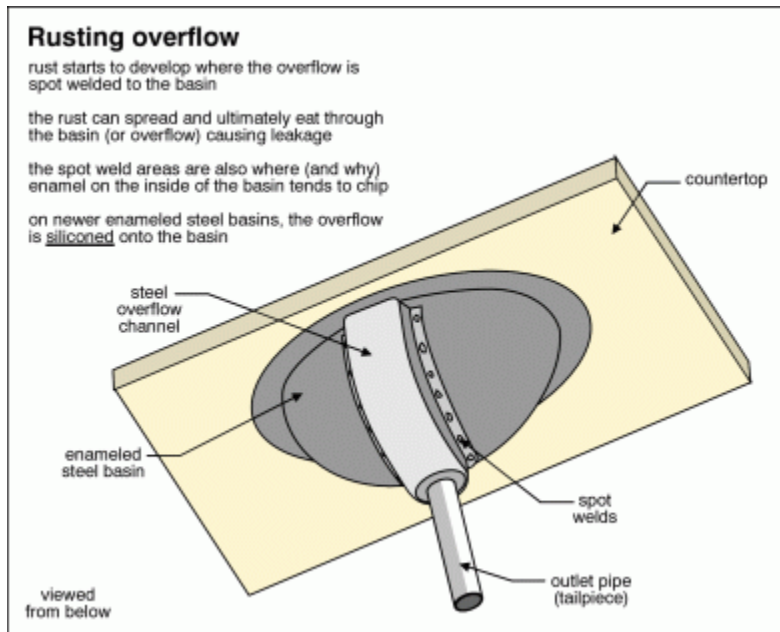
**Fixtures and faucets \ Basin, sink and laundry tub**

**Task:** Replace

**Time:** Unpredictable
